1.5 Million Natural Gas Connections Project in 11 Governorates

Zefta High Pressure Pipeline /Gharbia Governorate

Due Diligence

Final report

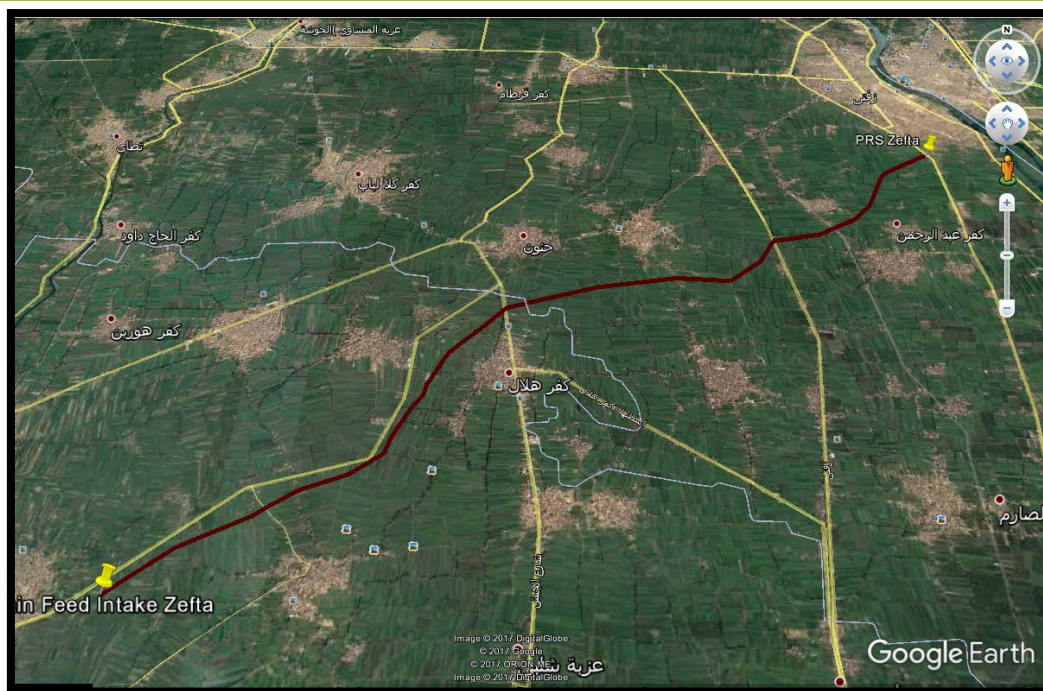
Figure 1-4: Off-take location

As mentioned above, the Off-take from the national grid and the HP pipeline (70 bar system) already exists. The Off-take is the point on the HP national grid pipeline where a branch of the pipeline is constructed to connect a new PRS to the national grid. At the Off-take location, valve rooms/valve ditching is constructed so as to control the flow of the natural gas through the pipeline (branch). These valves work like gateways for the Zefta area.
